The San Diego Real Estate  
Inspection Company

## Inspection Report

**Property Address:**  
777 Mac Court  
San Marcos CA 92069

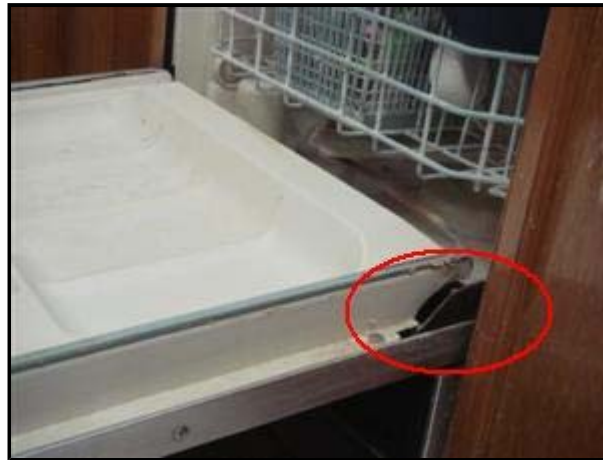
1.0 Picture 1

(1) The dishwasher is in poor condition. The door hinges are broken and the door springs are not functioning properly. The interior has a heavy layer of calcium. The dishwasher was not run due to the poor condition. Recommend replacement.

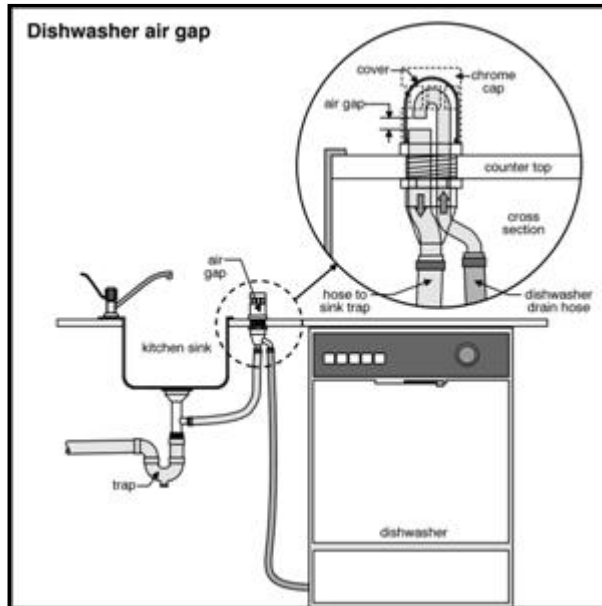
(2) No air gap was installed for the dishwasher. An air gap is required to prevent dirty water from being sucked back into the water supply. Recommend installation of an air gap by a qualified plumber.

Diagrams inserted to illustrate proper configuration.

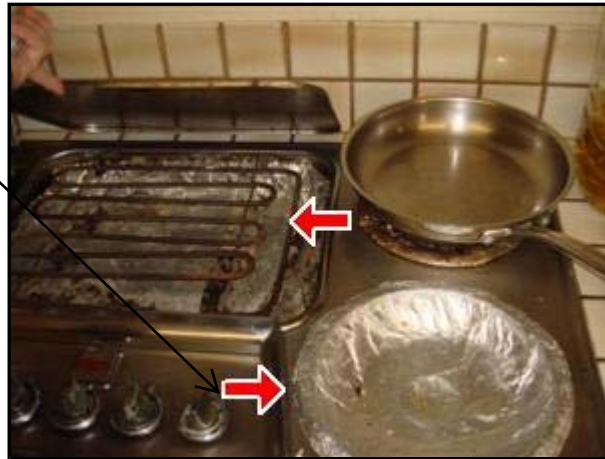
1.1 Picture 1

The electric range is in poor condition. The front right coil was missing, and the griddle was missing. Recommend replacement.

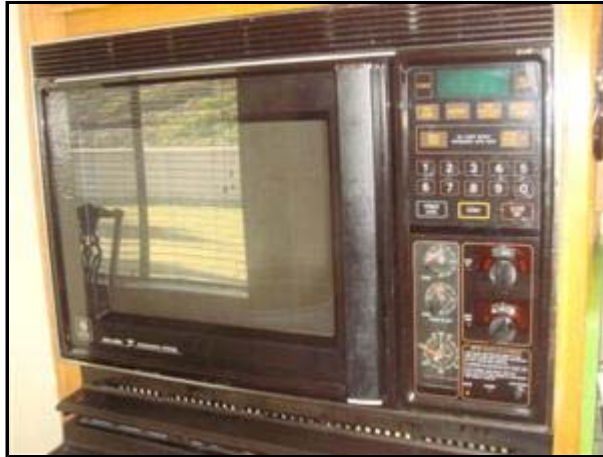
1.4 Picture 1

The microwave was tested and was functional at time of inspection. However the microwave appears to be original, and is an older unit. recommend budgeting for a new microwave as the life remaining is limited. Microwave and wall oven are one unit, so both will require replacement simultaneously.

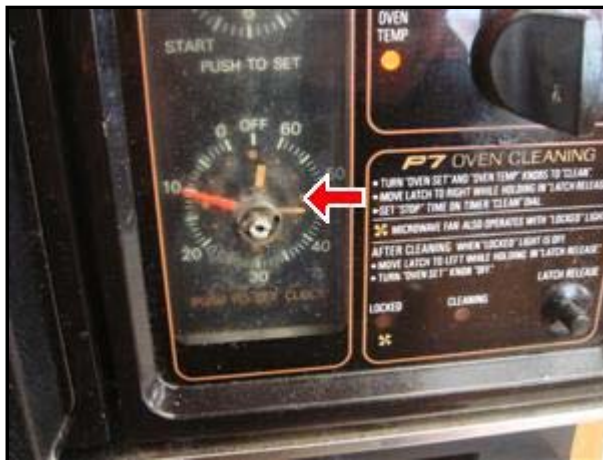
1.5 Picture 1

Wall oven was tested and functional at time of inspection. The timer and timer knob are damaged.

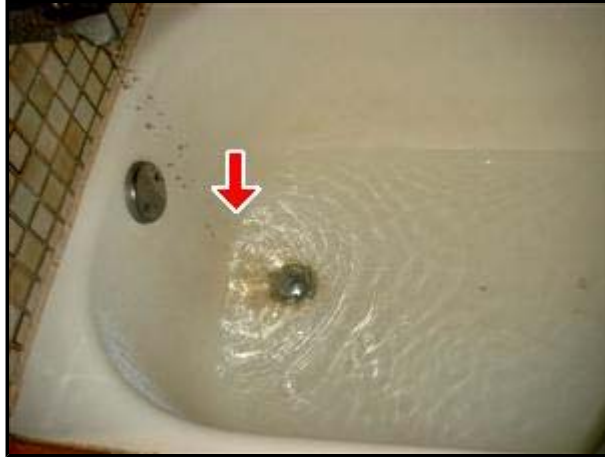
2.0 Picture 1

IN	NI	NP	RR	Inspection Items
<input type="checkbox"/>	<input type="checkbox"/>	<input type="checkbox"/>	<input checked="" type="checkbox"/>	<b>2.0 INTERIOR DRAIN, WASTE AND VENT SYSTEMS</b> <b>WASHER DRAIN SIZE: 2" DIAMETER</b> <b>PLUMBING WASTE: ABS</b> <b>Findings:</b> (1) Tub drains slowly in the upstairs hall bathroom. Recommend drain service by a licensed plumber.

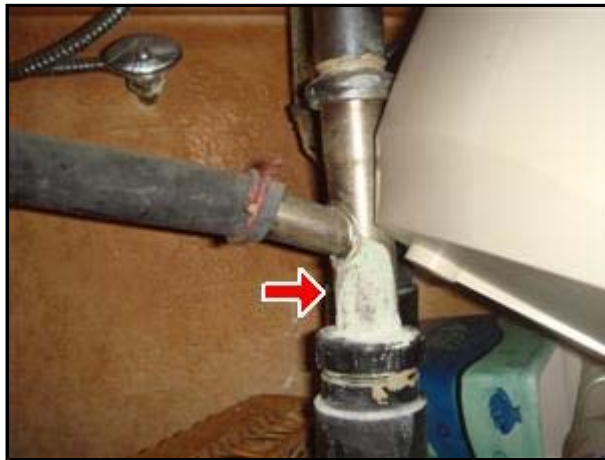
2.0 Picture 2

(2) The drain tube below left side sink in hall bathroom is corroded. Recommend replacement by a licensed plumber.

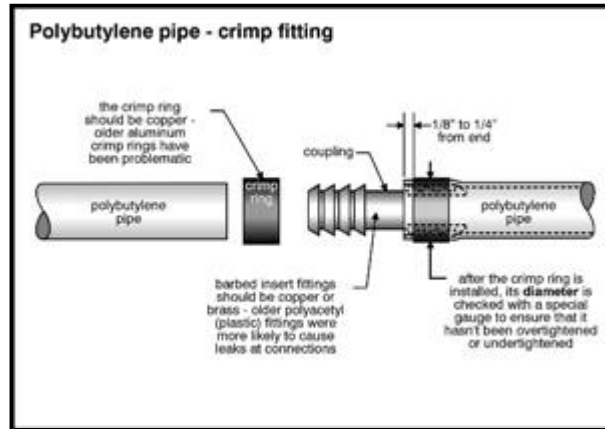
2.1 Picture 1

Polybutylene plastic plumbing supply lines (PB or QUEST) are installed in the subject house. Polybutylene has been used in this area for many years, but has had a higher than normal failure rate, and is no longer being used. Many of these systems were the subject of a recall. Copper and Brass fittings used in later years have apparently reduced the failure rate. This subject house has copper fittings. We recommend that you consult with a licensed plumber about this system, the potential for it to fail, and the cost of re-plumbing your house prior to the end of your contingency period. For further details contact the Consumer Plumbing Recovery center at 1-800-392-7591 or the web at <http://www.pbpipe.com>

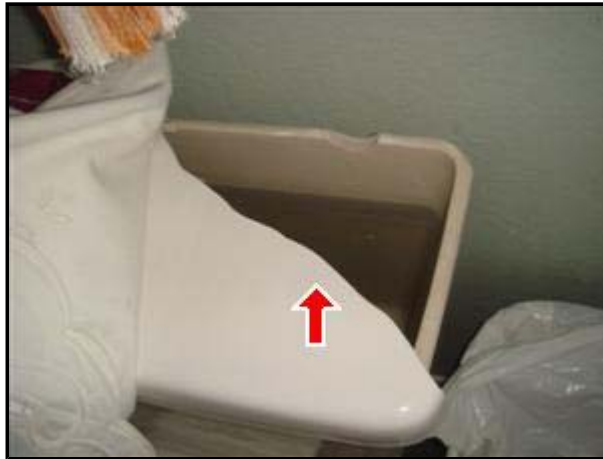
2.2 Picture 1

- (1) Toilet tank lid in master bathroom is broken. Recommend replacement.

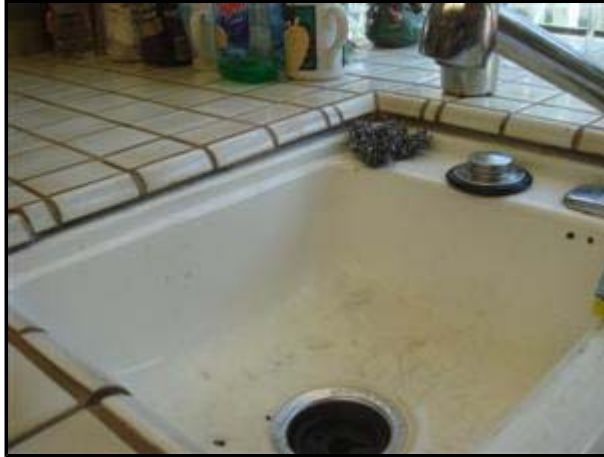
2.2 Picture 2

- (2) Sink faucet in Half Bath is corroded. Advise replacing to prevent future leaks.

- (3) Kitchen sink is chipped and has dropped below counter. This can allow water to enter the cabinet below. Recommend repairing the cause of the failure, and caulking around basin perimeter.

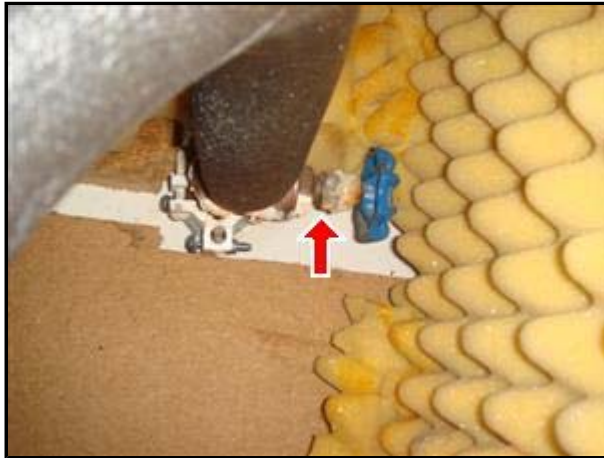
2.2 Picture 3

(4) The water shut off valve at water heater is corroded. Recommend replacement when water heater is replaced.

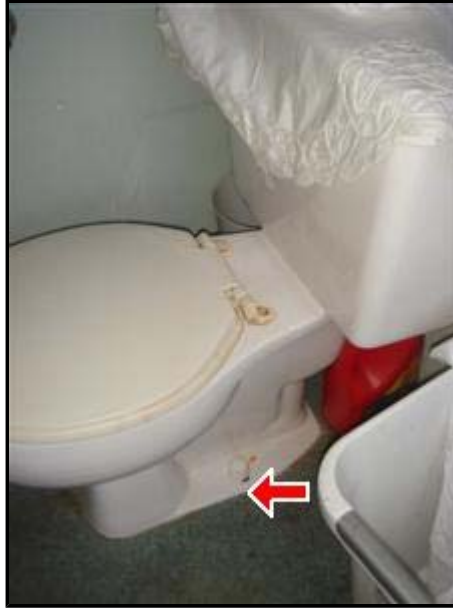
2.2 Picture 4

(5) Toilet in master bathroom is loose on floor. Recommend repair by a licensed plumber.

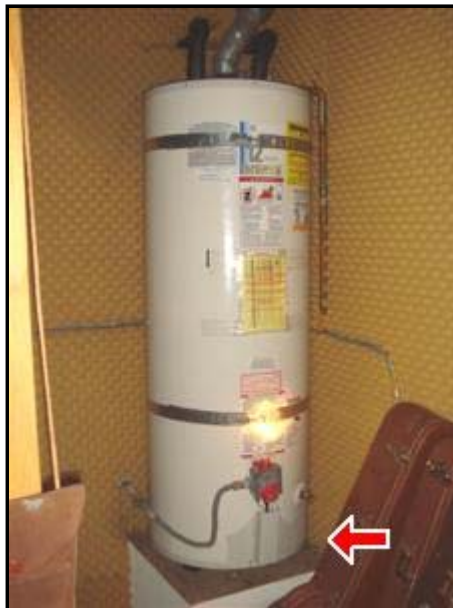
2.4 Picture 1

An active leak was observed at the water heater. Standing water was located inside the burner compartment. Recommend replacement by a licensed plumber to avoid leaks which could cause property damage.

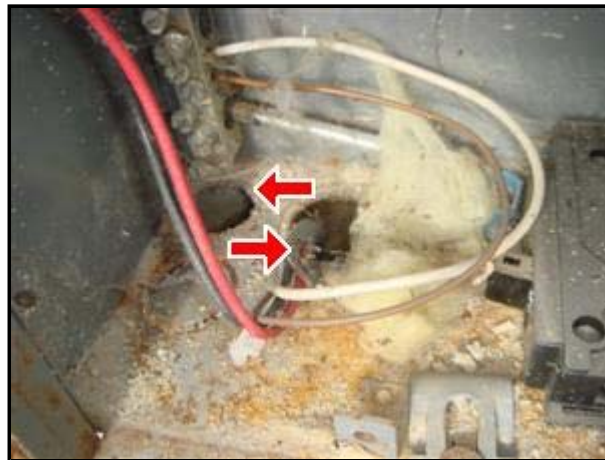
3.0 Picture 1

(1) Knockouts noted missing from inside the panel. We advise installing cover inserts for safety.

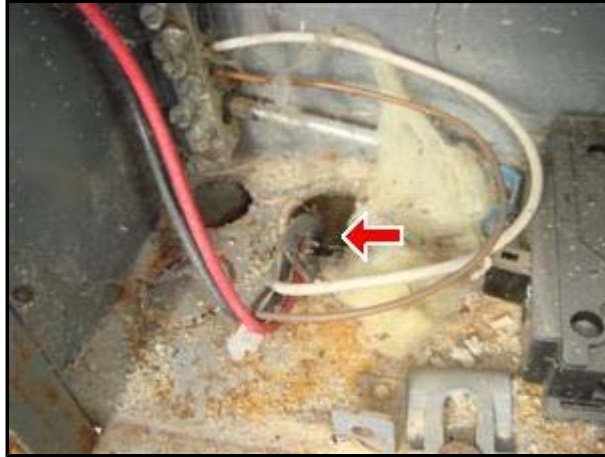
3.0 Picture 2

(2) Wire clamp missing at main panel. A plastic bushing or wire clamp protects and secures the wiring as it enters into the electric box. We advise corrections by a lic electrician.

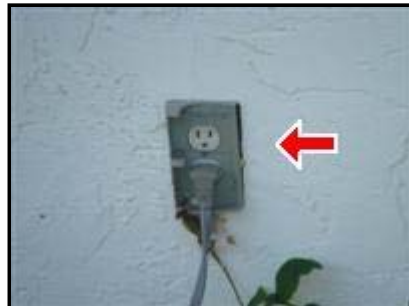
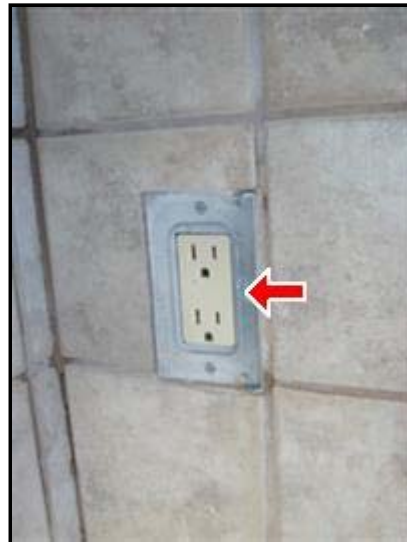
3.2 Picture 1

- 3.2 CONNECTED DEVICES AND FIXTURES (Observed from a representative number operation of ceiling fans, lighting fixtures, switches and receptacles located inside the house, garage, and on the dwelling's exterior walls)**  
**Findings:**  
 Weather proof covers are required at exterior receptacles.

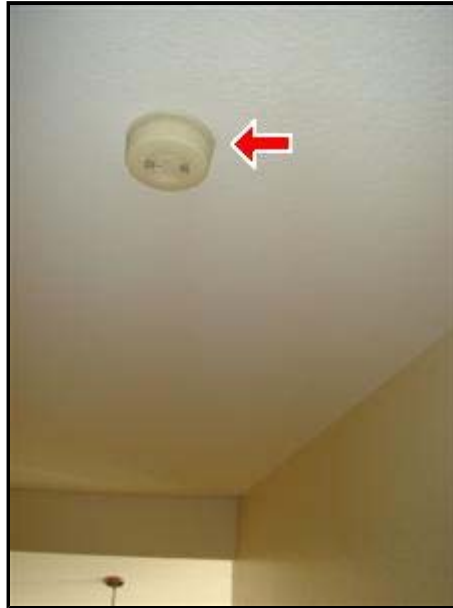
3.7 Picture 1

Hard-wired smoke detector in stairwell did not work when tested. Recommend replacement with like-kind detector.

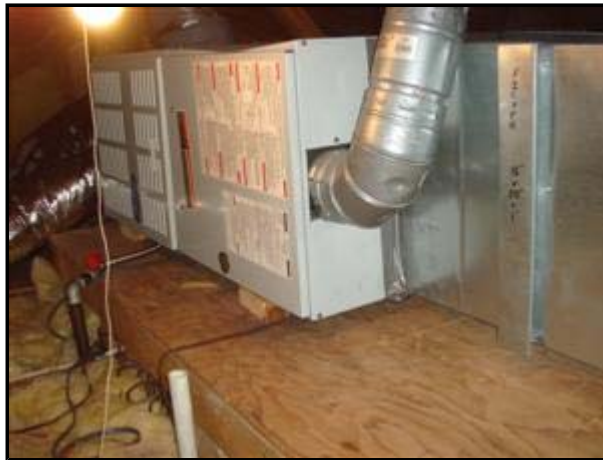
4.0 Picture 1

(1) The furnace was manufactured in 2000. This is a newer furnace, but the furnace failed to operate when tested. Recommend further inspection and repair by a licensed HVAC contractor.

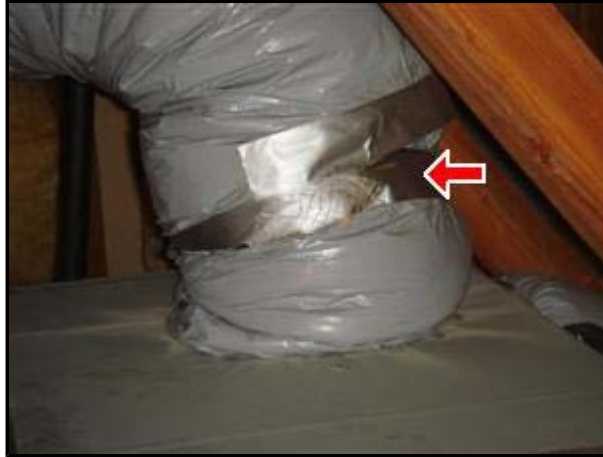
4.5 Picture 1

Poor repairs were observed at the ducting in the attic. The ducts were repaired with duct tape, but duct tape fails over time. Recommend having the ducts sealed by a licensed heating contractor.

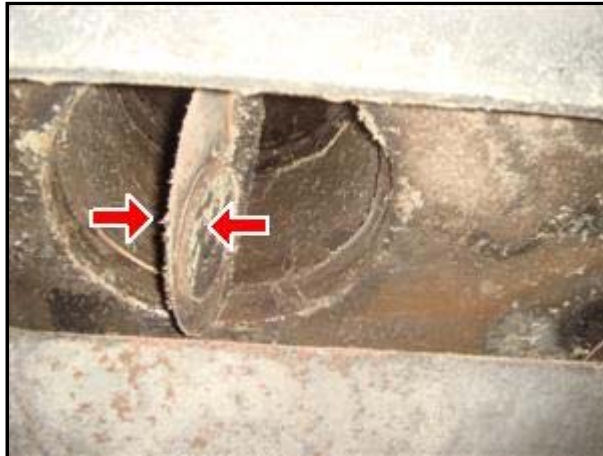
4.7 Picture 1

A damper clamp is required at the damper when concrete gas logs are used in the fireplace. This damper clamp prevents the damper from closing all the way as a safety precaution. If the damper is closed, Carbon Monoxide gas can enter the living space which is undetectable. Recommend installation of a damper clamp.

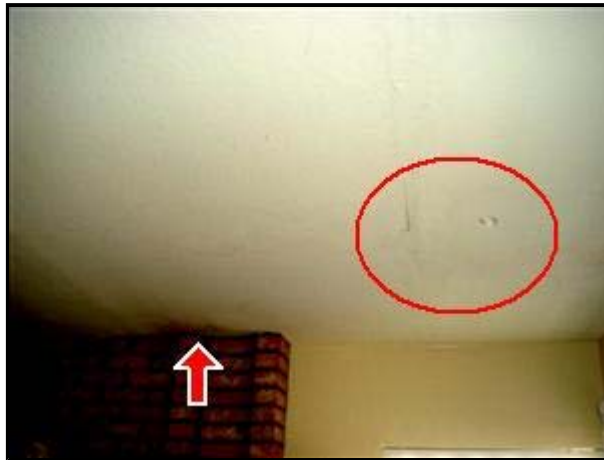
5.0 Picture 1

Water stains were observed at several locations in the house. Stains in the family room appear to be from a plumbing leak at the master bathroom. The water stains in the living room appear to be from roof leaks.

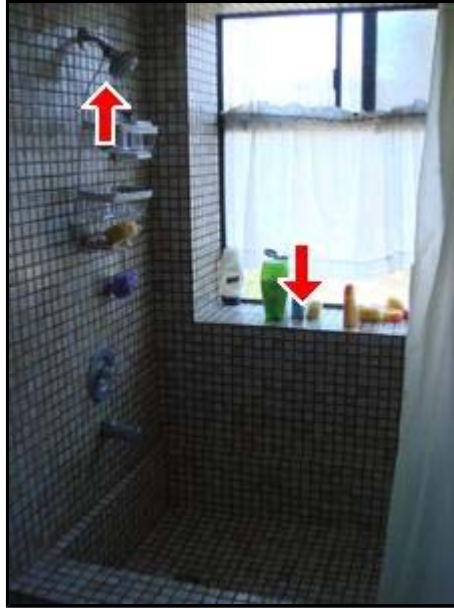
5.3 Picture 1

Window noted installed too low at shower stall. Windows are required to be installed at least five feet above the shower floor to prevent water damage to the window frame. We advise contacting a licensed general contractor to make necessary corrections. This window may be the cause of the water leaking into the family room.

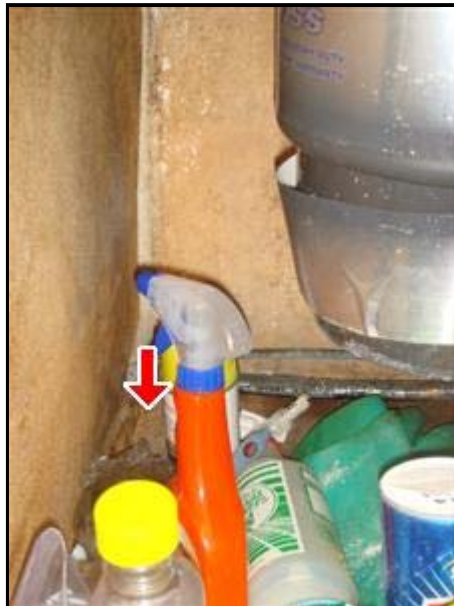
(2) Mold and mildew odor noted under the kitchen sink. This may be a health and safety concern. We advise obtaining further evaluation from a qualified expert to determine the extent of the necessary corrective measures required.

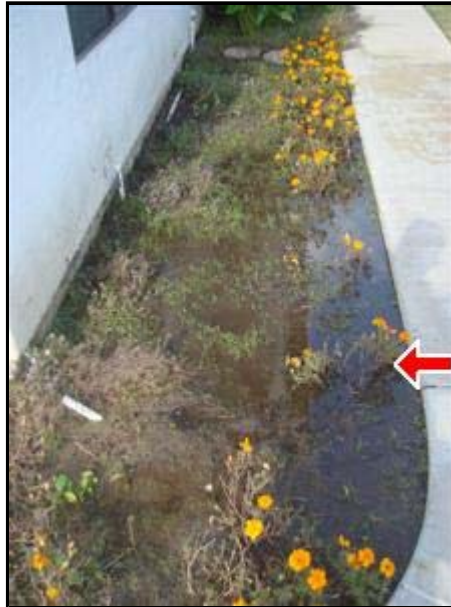
6.6 Picture 1

Some water collects at the plaster at rear of house. Recommend correction by raising the level of soil or installing a yard drain.

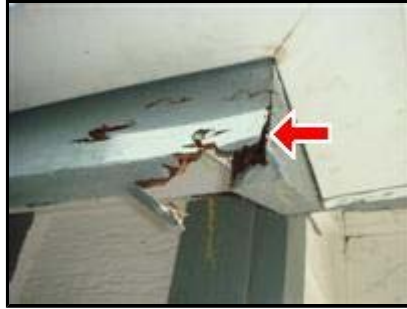
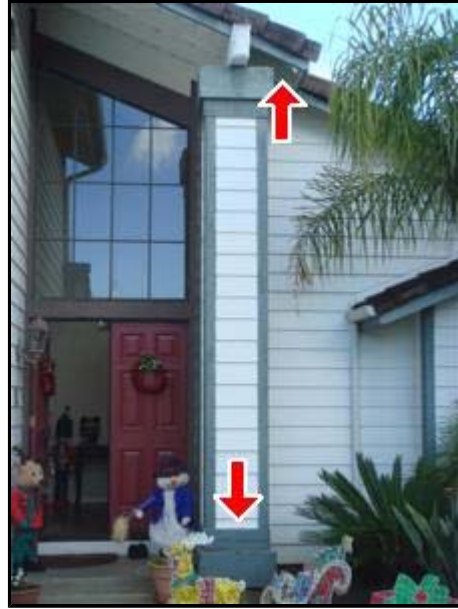
6.8 Picture 1

Several areas were observed with damaged wood. recommend referring to the pest inspection report for a full evaluation and suggested remedies.

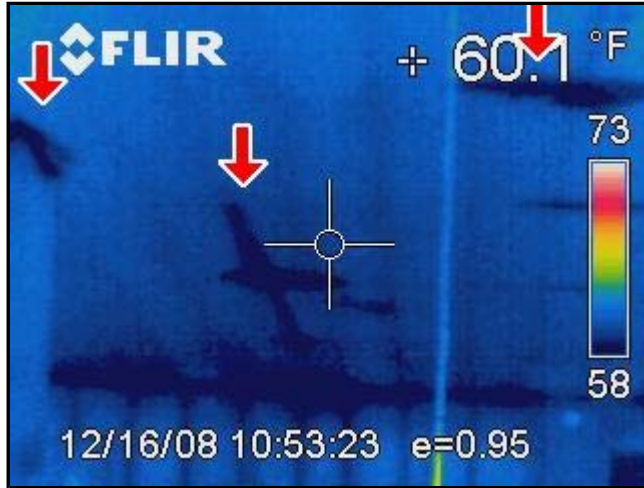
7.0 Picture 1 Thermal image of ceiling

(1) Thermal imaging reveals evidence of roof leaks were observed in the living room. At least two broken tiles were observed and several tiles are out of position. Recommend having the roof inspected and repaired by a licensed roof contractor.

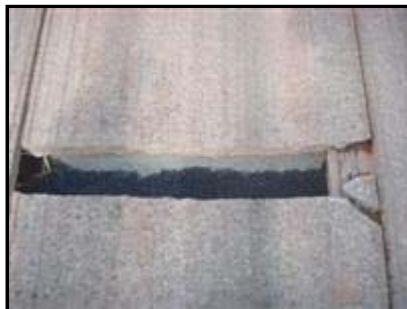
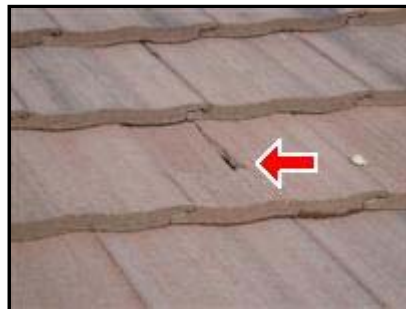
7.0 Picture 3

(2) Pictures of cracked tiles.

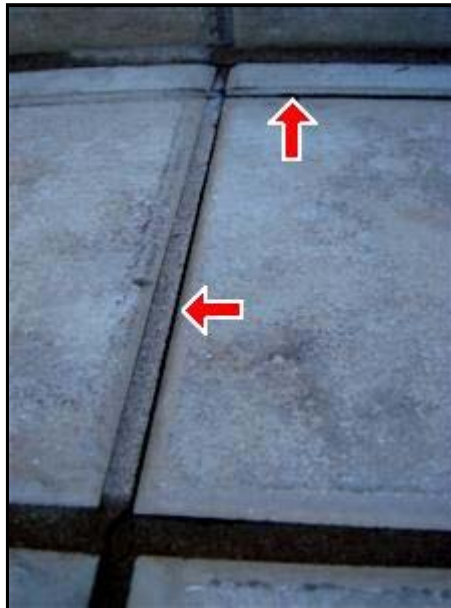
11.1 Picture 1

Some of the tiles are cracking. It appears that moisture has gotten between the tiles. Several tiles are loose.
