Insider's Guide to Home Inspections

Buying a House Built in the 1970's

The Real Estate
Inspection Co.

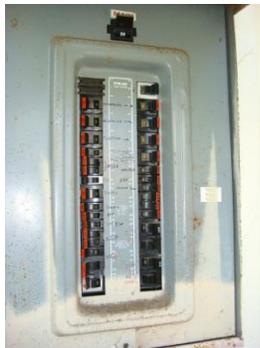
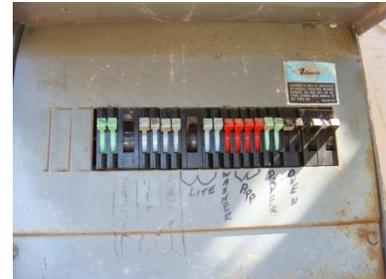
Some houses built in the 1970's have electrical panels that are no longer considered safe. The two brands of panels that should be replaced were manufactured by Federal Pacific Electric

(left) identified by distinctive orange-tipped breakers, and Zinsco panels which are typically horizontal, and have multi-colored breakers (right).

Both of these brands of panels have a poor reputation and have been suspected of causing house fires by over-heating, or breakers that fail to trip when over-loaded. If you have either of these

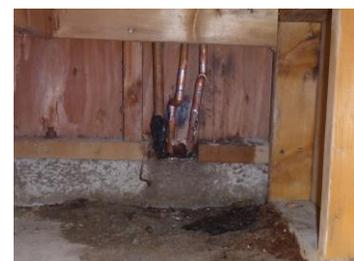
The majority of houses built in the 1970’s have copper distribution pipes and ABS plastic drain lines. These are both desirable materials. The only problem with construction techniques at the time was the installation of copper pipes through the slab. The alkalinity of concrete deteriorated the copper pipes, and was the cause of “slab leaks”. There is no way to predict if a slab leak will occur until it happens. There is a higher probability for a slab leak when the copper pipes are run through the concrete.

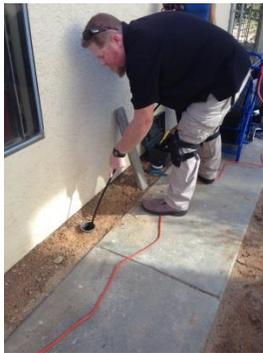
A drain line video inspection is highly recommended for houses with mature trees over drain lines. Even with ABS (black plastic) drain pipes, roots can lift and damage glue joints allowing root intrusion. The drain line video will show if the buried pipes are damaged, clogged, or filled with roots. This is important because replacing a damaged drain line between the house and the sewer can be expensive.

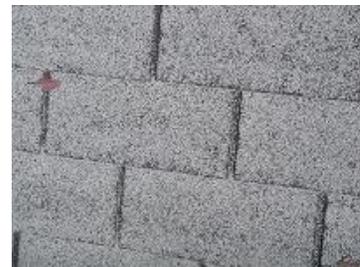
An asphalt-shingle roof is also likely at the end of its life. It is made of oil-impregnated fiberglass material, with an aggregate (which looks like kitty litter) pressed into the surface. The aggregate adds color, but its primary purpose is to protect the shingles from UV exposure. Once the aggregate is worn, the shingle deteriorates rather quickly. Most of these roofs are rated for 20 or 30 years. Do the math. If the roof looks worn it is likely in need of replacement.

A 20-year rated roof, replaced once in the 1990’s, may well be nearing the end of *its* life (1973 roof replaced in 1993, and again in 2013).

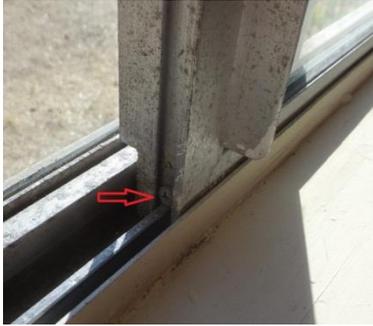
Most windows installed in the 1970's have aluminum frames. We often have clients who are disappointed to find that the house they want to buy has single pane windows. Be sure to check this out. The most common problem we see with older windows consists of worn glides or rollers. This makes the windows difficult to slide. This is considered a hazard. The added force required to slide these windows could cause the window to be slammed shut resulting in broken glass.
